Superduty

***No Pedal Response & No Gauges
Problem***

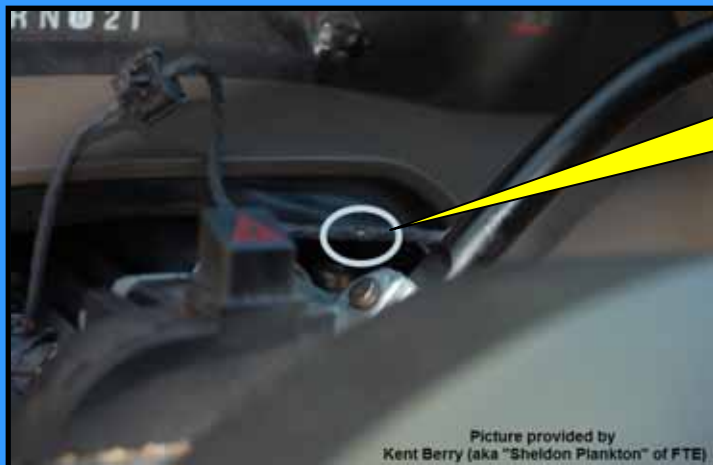
Look at Fuse # 45 (**Fuse #19 on the 99-01 trucks**) to see if it is blown, if it is blown, you should look at the shifter wire.

Chafe
Damage

This wire after years of movement will chafe on the steering column and eventually contact something and blow the fuse that controls the pedal and cluster. It is pretty easy to fix by splicing the wire or just protecting it with electrical tape or heat-shrink.

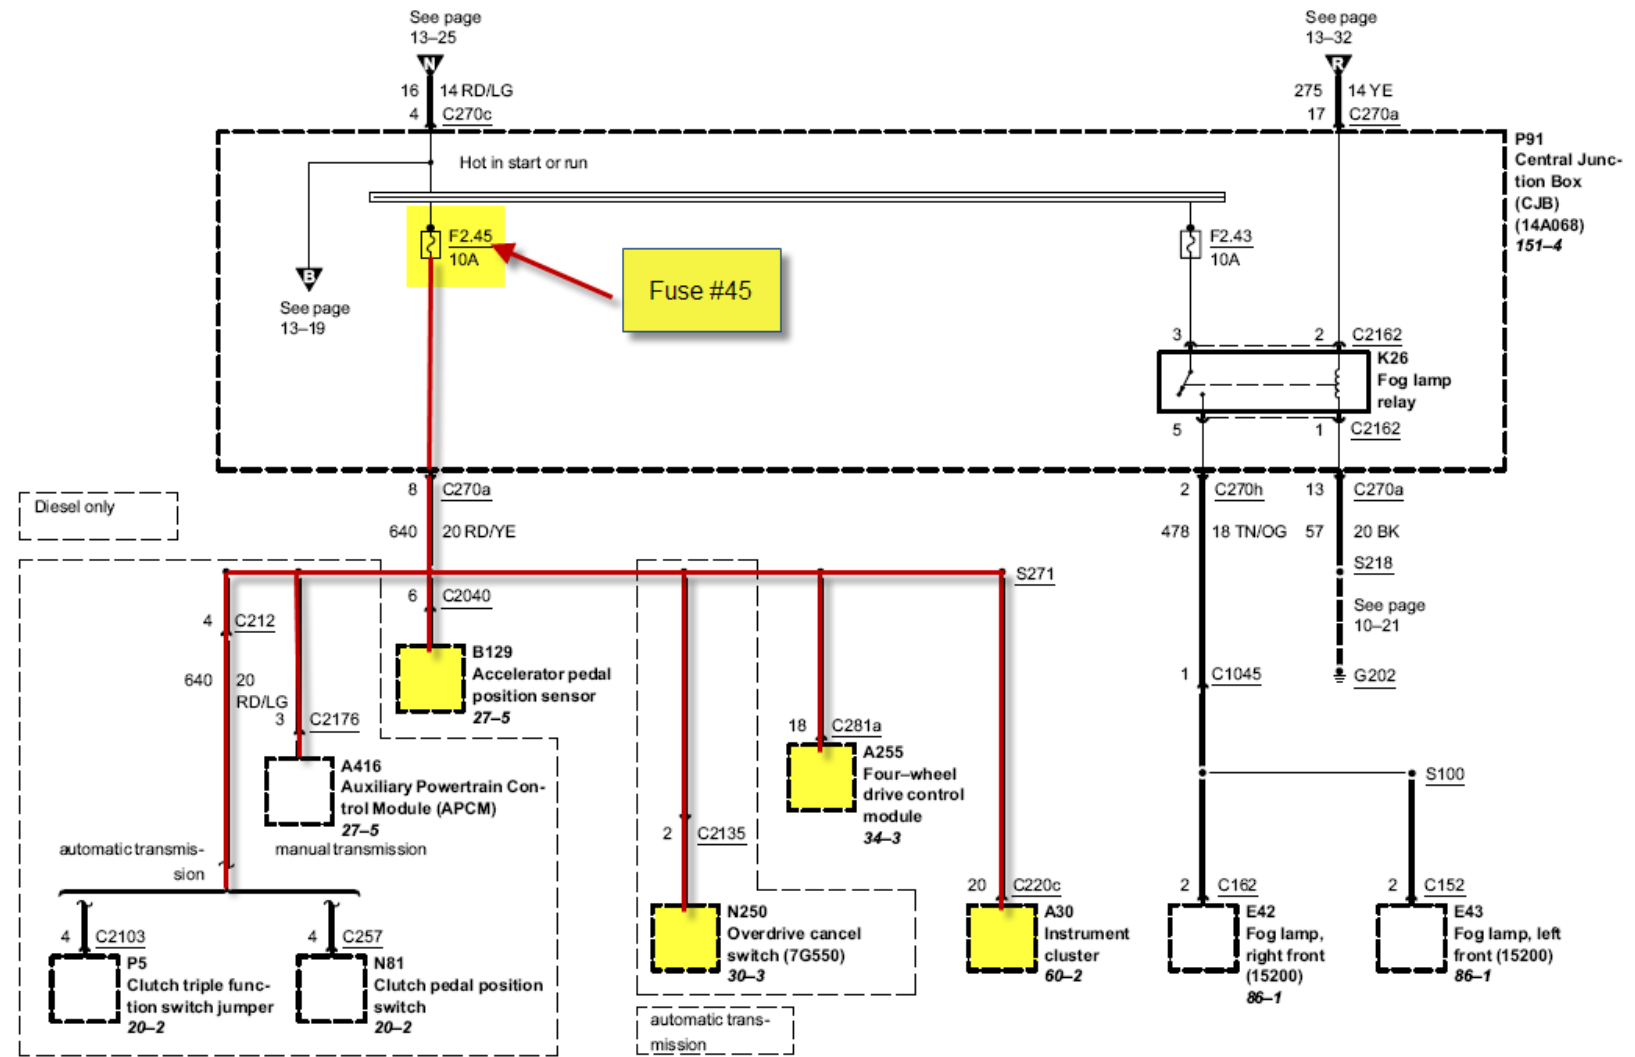
Pickup, F2.43, F2.45

Fuse #45 (Fuse #19 on the 99-01 trucks) is shared by various components, any one of the grounding out will cause a short that will blow the fuse.

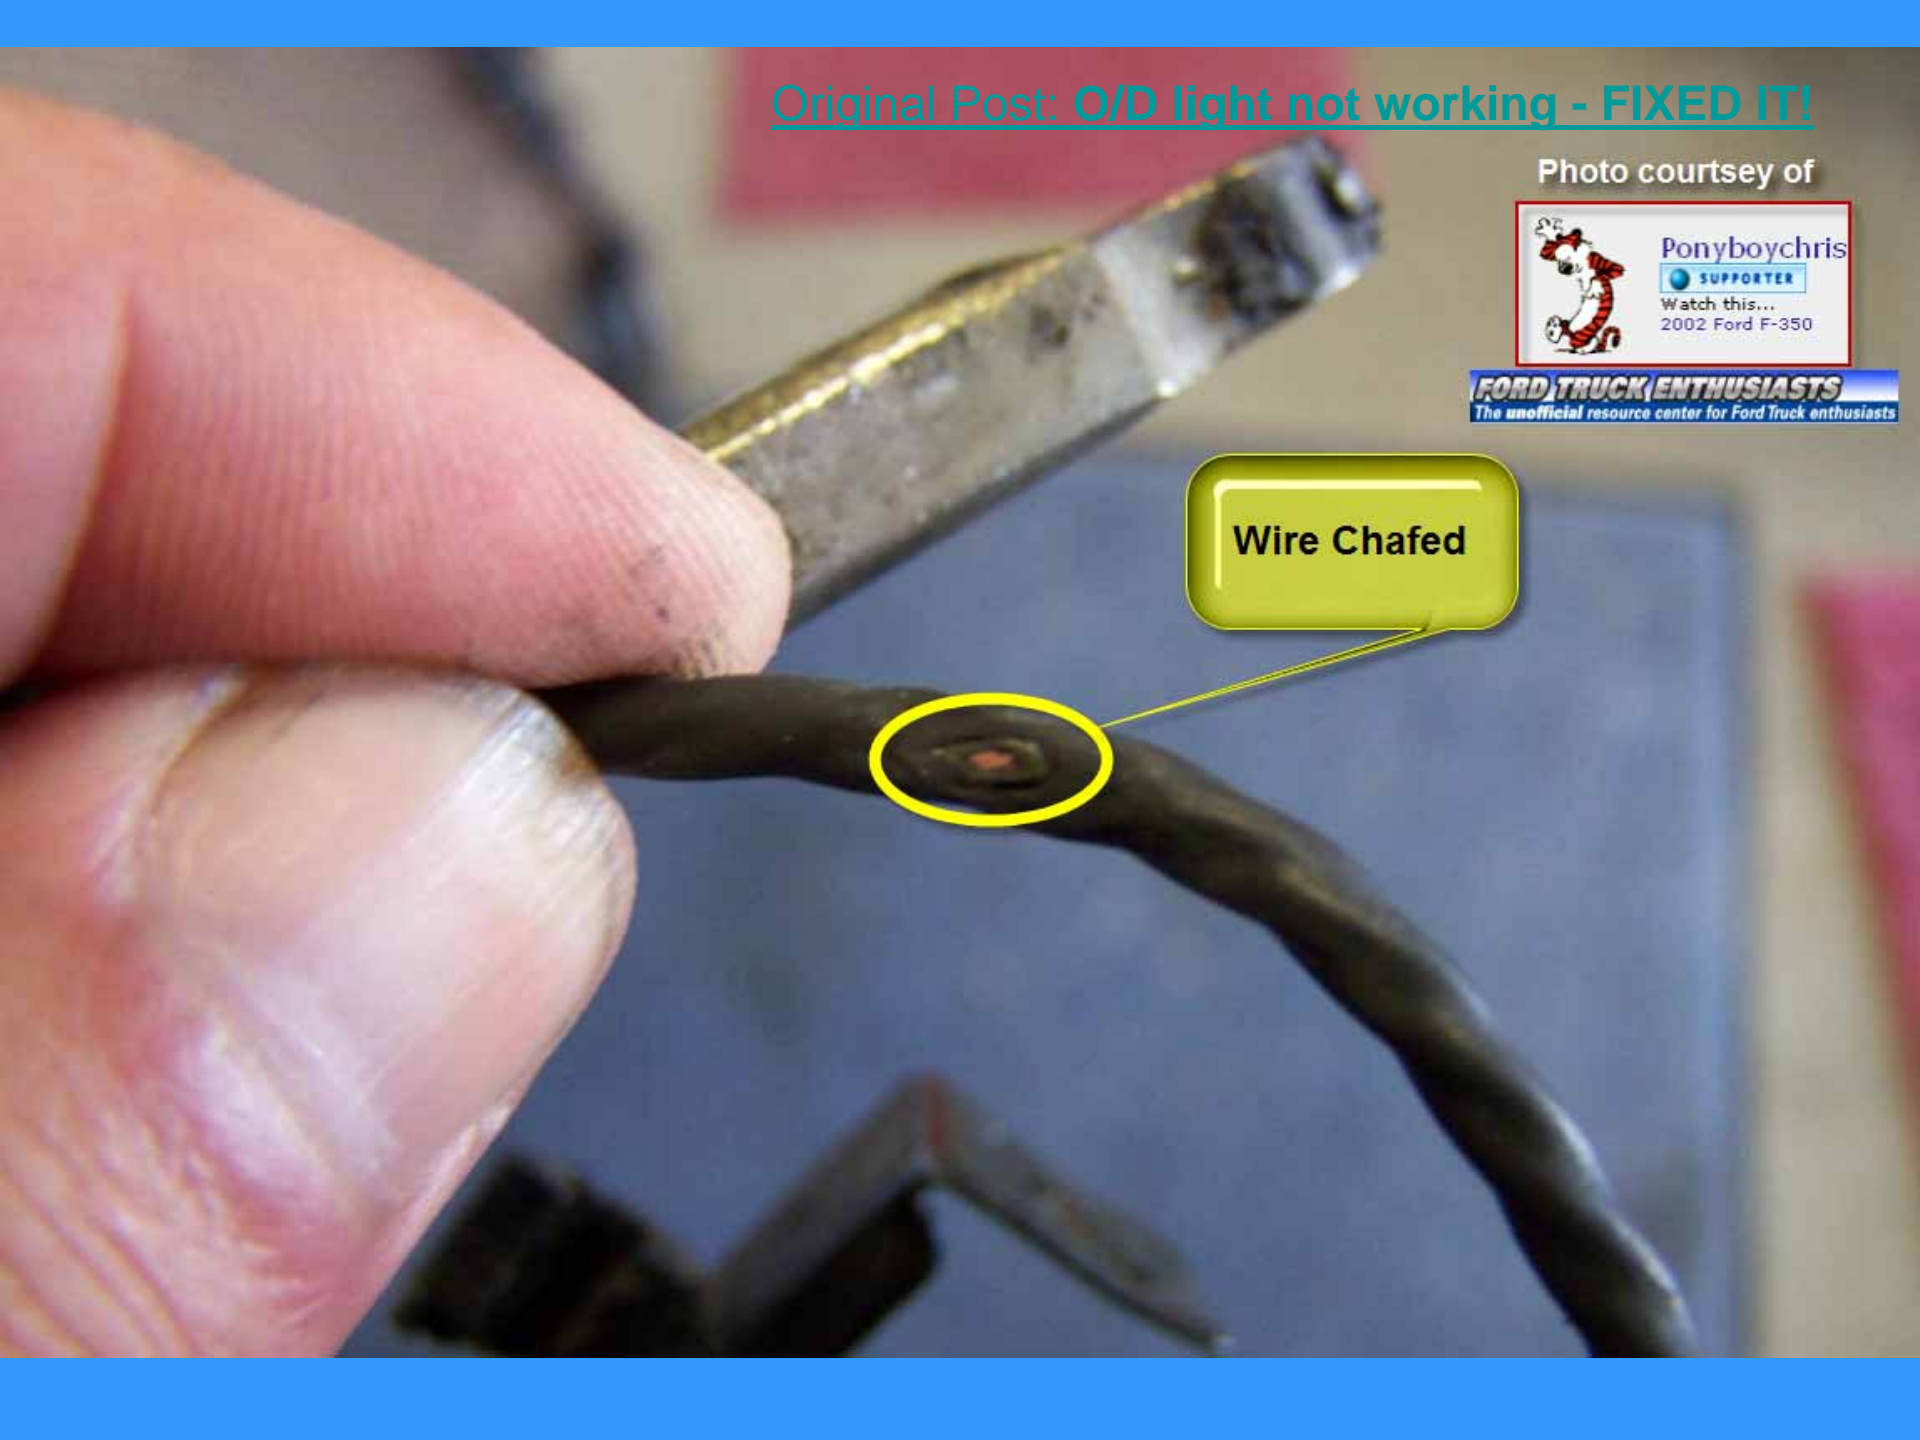
Wire Chafed
