This information was found in an internet forum. I do not have the original author's name. This is not my idea, but I have used the information below to fix one of my power door lock actuators and it worked.

WARNING: The following is long winded, but if you want your PDL's to work again WITHOUT spending any \$\$ read on.

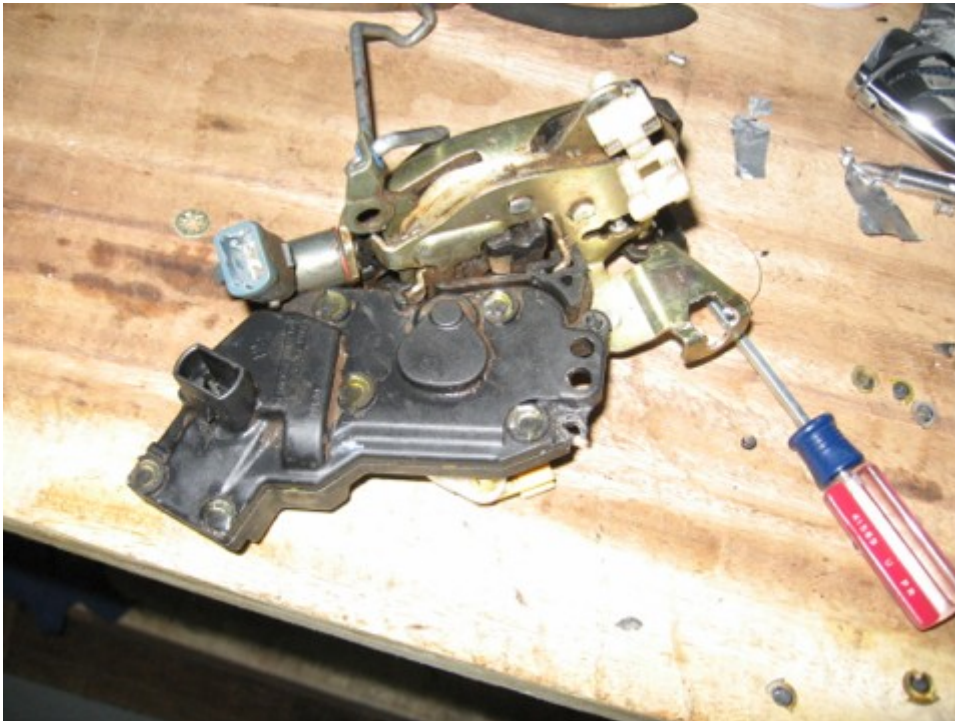
Pic one is the unit after the two rivits were removed

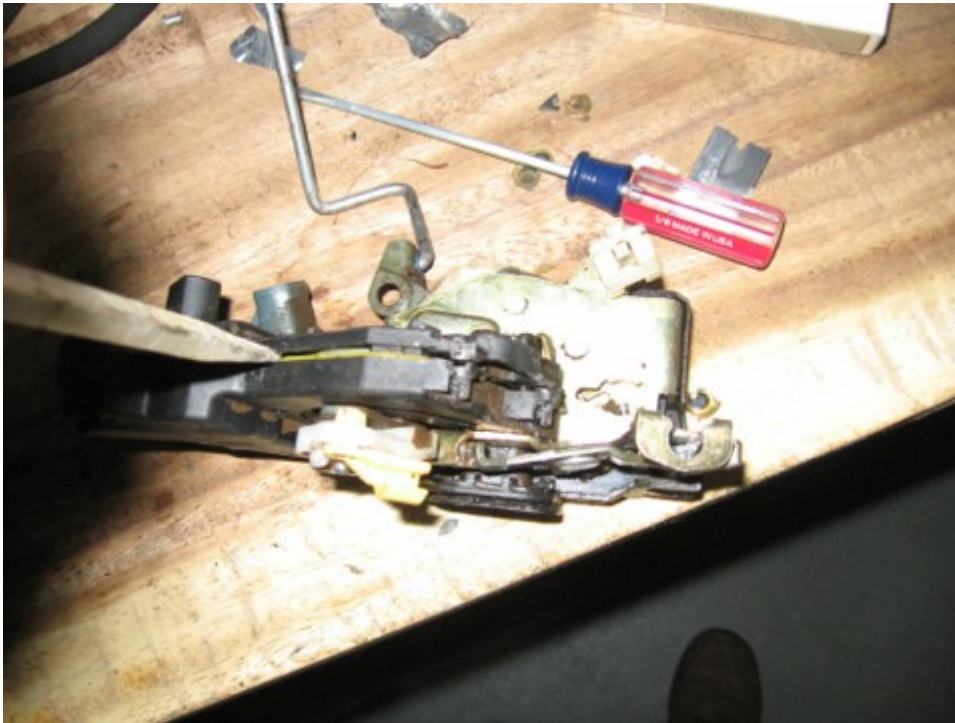
Prying the unit apart

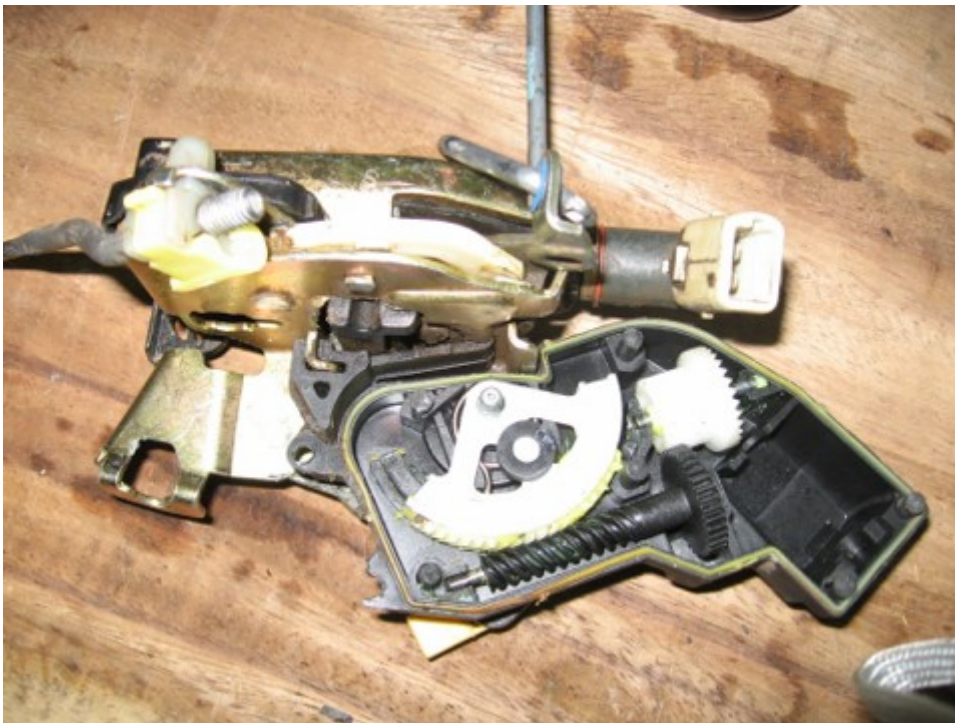
The open unit minus the motor

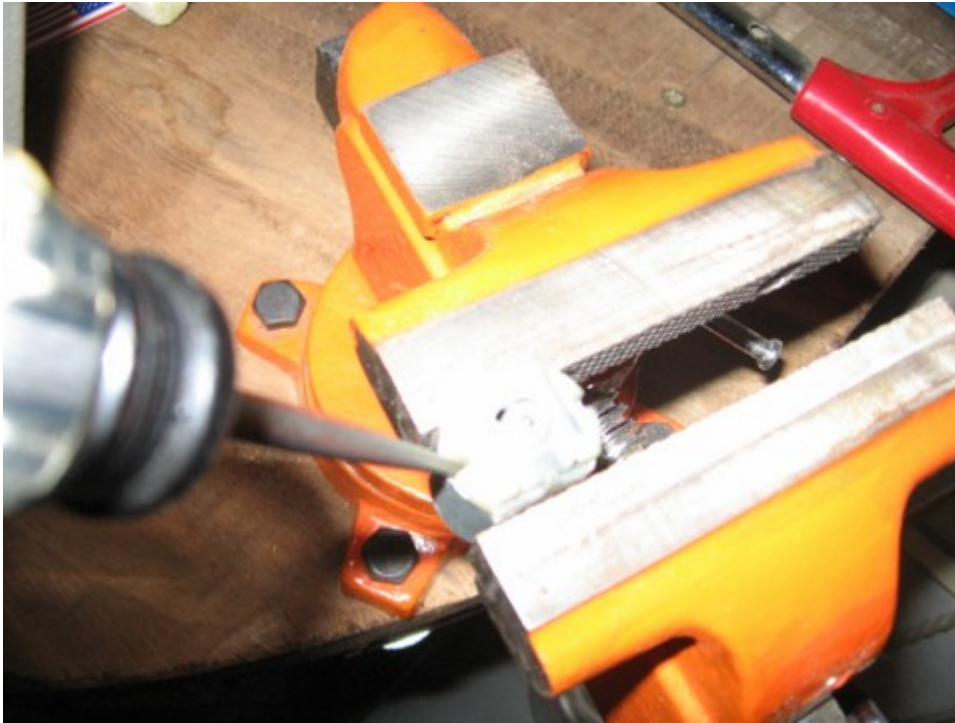
Prying the two tabs open on the motor

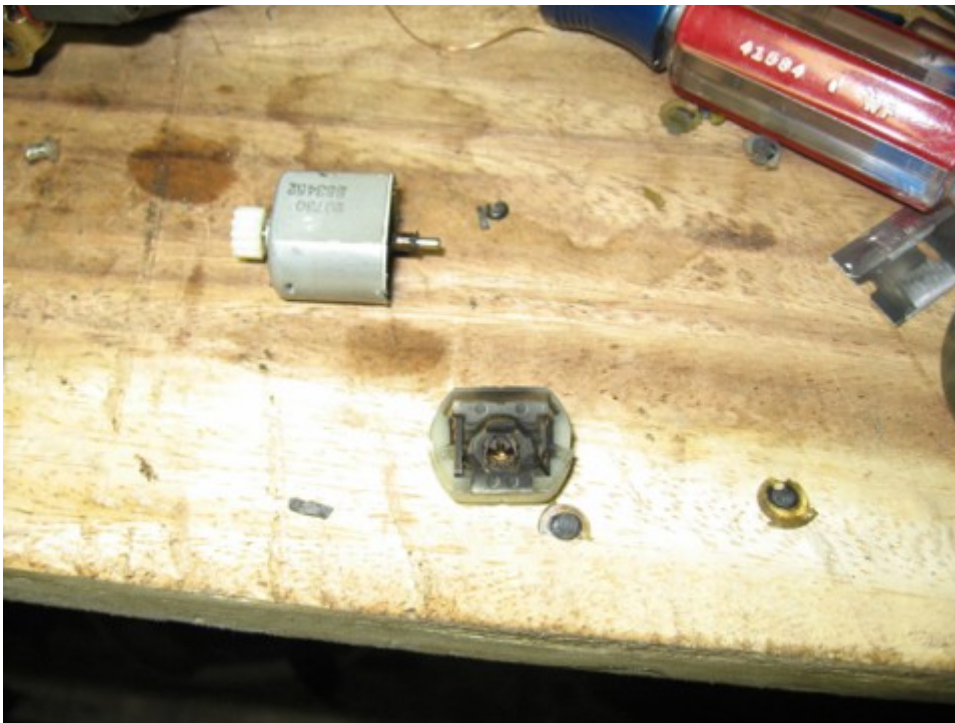
The opened motor the little metal piece to wrap in tin foil is on the left side of the cap

money on than actuators. I took a small piece of aluminum foil and wrapped the "thing" voila! Perfectly working motor! I sat there and operated the thing for 10 minutes including one or two times stopping the armature and holding down the switch to see what would happen. The motor builds heat, but not much. Not enough to worry about. Now that I had a good working motor I decided I would try and reassemble the unit. The problem is you cannot glue the unit together as there is a rubber gasket around the perimeter of the case and if you tried to glue the rods into the case, you would not have enough pressure on the two halves of the case to keep the gears in place (these things actually apply a great deal of torque on the case) What I decided to do is completely break off the plastic rods flush with the bottom side of the case and then drill out the bottom case and screw it together. This worked perfectly. You'll need screws that are the same diameter as the holes in the top of the case to keep it from "wandering". Also the screws should not protrude through the back of the unit as some of the mechanism has some pretty close tolerances and a screw sticking through the back would not allow some of the mechanism to work (this can be remedied with a decent set of wire dikes or a hacksaw). I know all of this is hard to picture, but if you do decide to try this fix, you'll see what I am describing here. The locks are back in and working flawlessly.
