E4OD High Performance Rebuild

Written by RacerX

This is a 1997 E4OD 4X4 model which will be upgraded and strengthened for competition. What's left of the build tag tells me it was manufactured on June 6 1997. Some chain re-builders remove the tag and discard it making ID more difficult and the exact build date impossible to know. After a thorough exterior cleaning, it will be dried and taken in for disassembly.

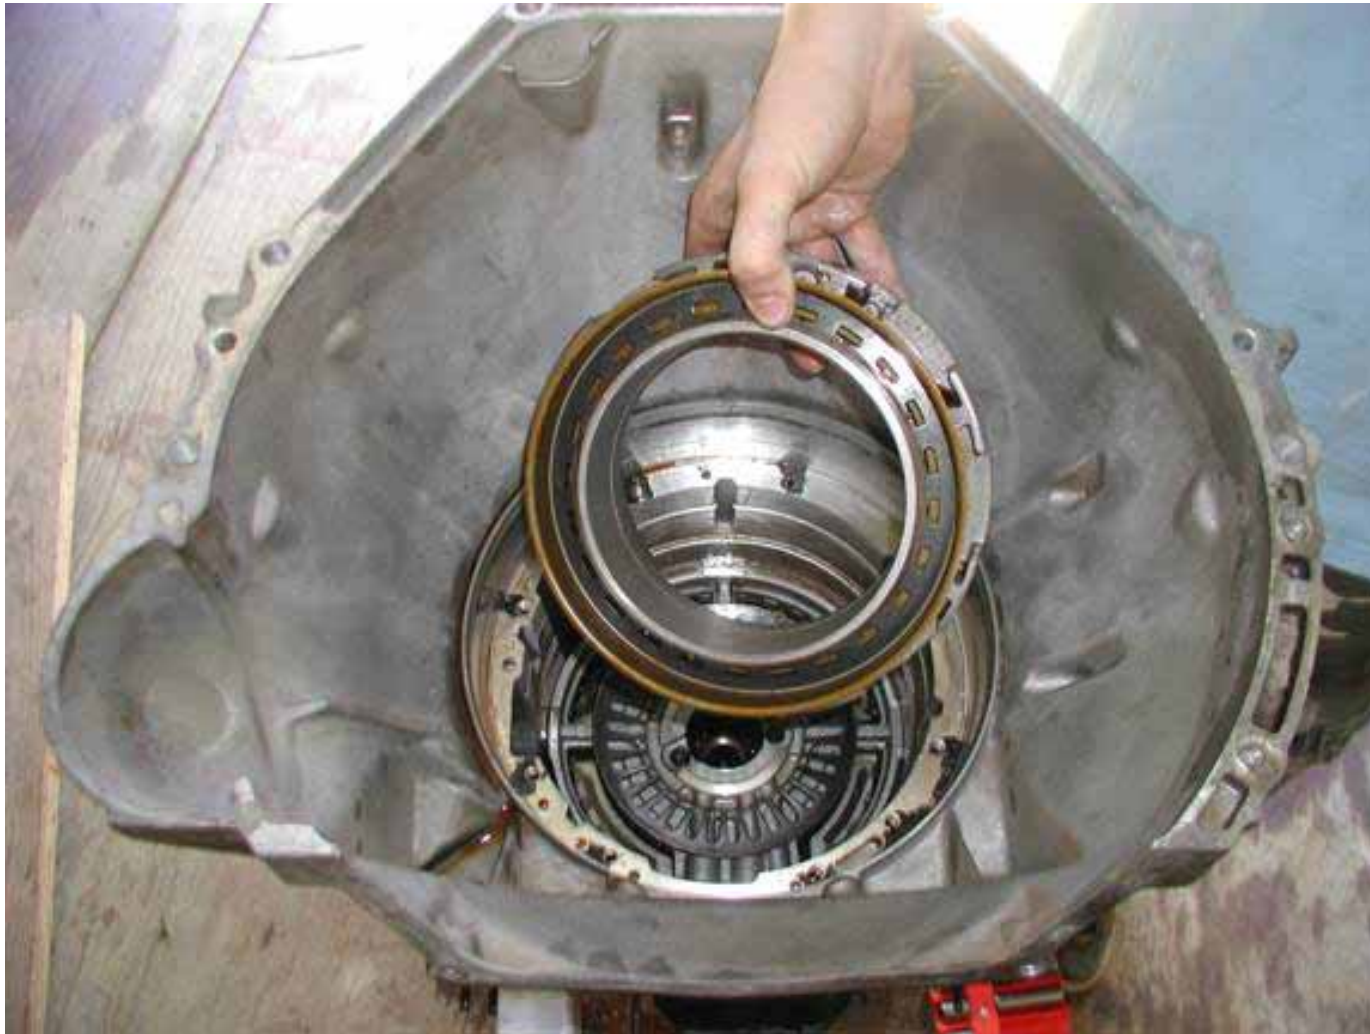
The Center Support is removed next (Rear side shown). A thrust washer will remain on the CS or be in the case. Notice the ball bearing in the center hub. Early models didn't come with a bearing and had fewer case contact areas. Case failure was a result. The early units can be corrected.

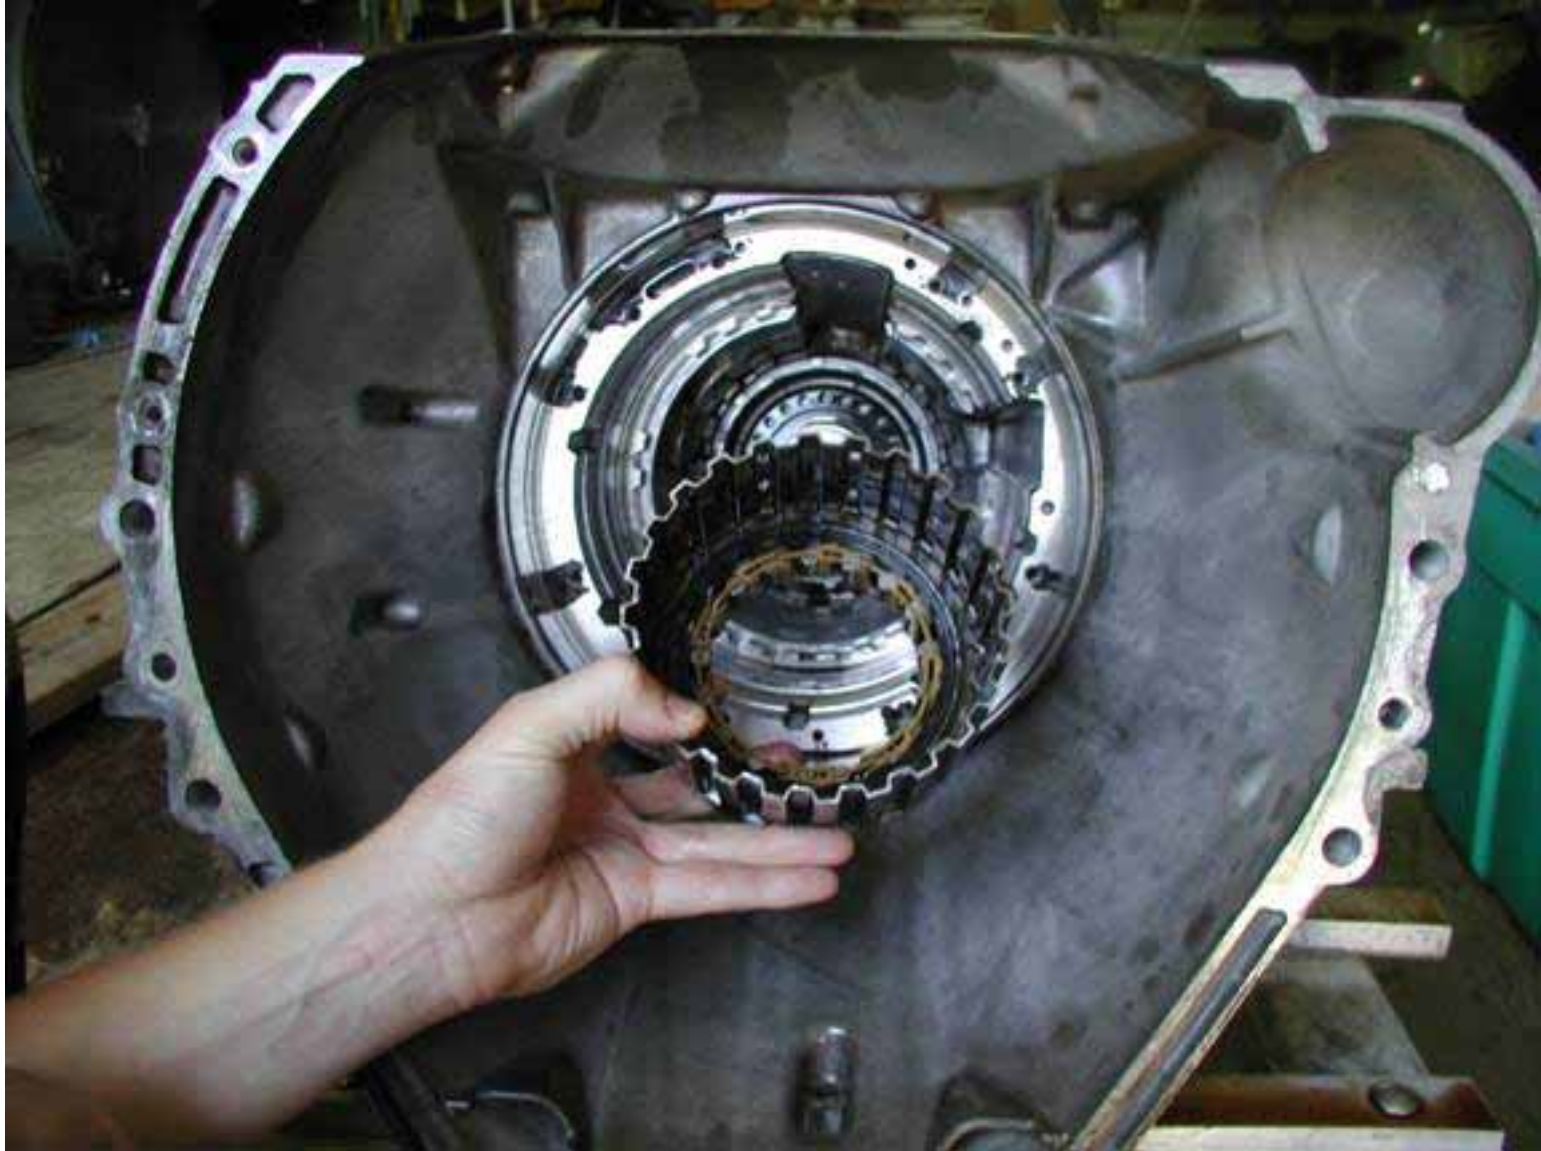
Now the low reverse drum is removed. The stamped steel construction of this design can be flexed by hand like a paint can. Not strong enough for this particular build. Unfortunately the 4R100 which replaced the E4OD is full of stamped steel parts.

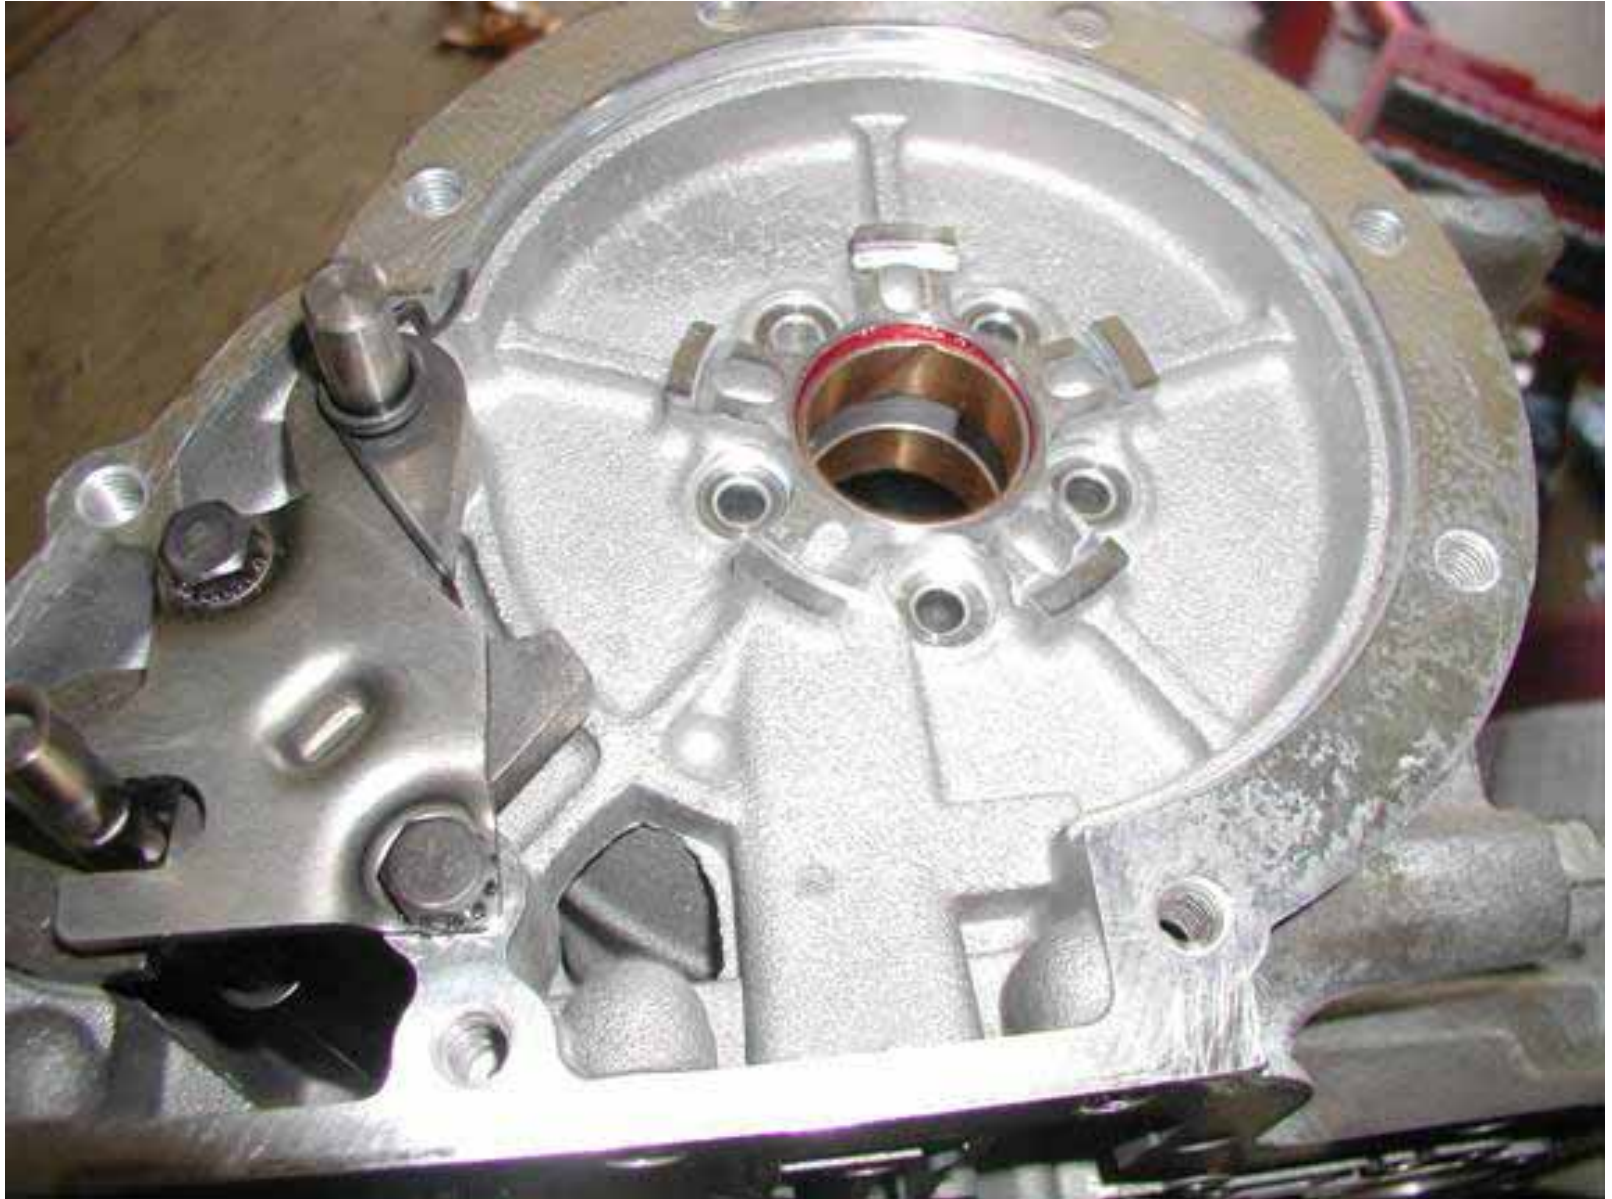
A new rear case bushing has been installed. Lube hole must align with hole in bushing or Lube failure will occur.

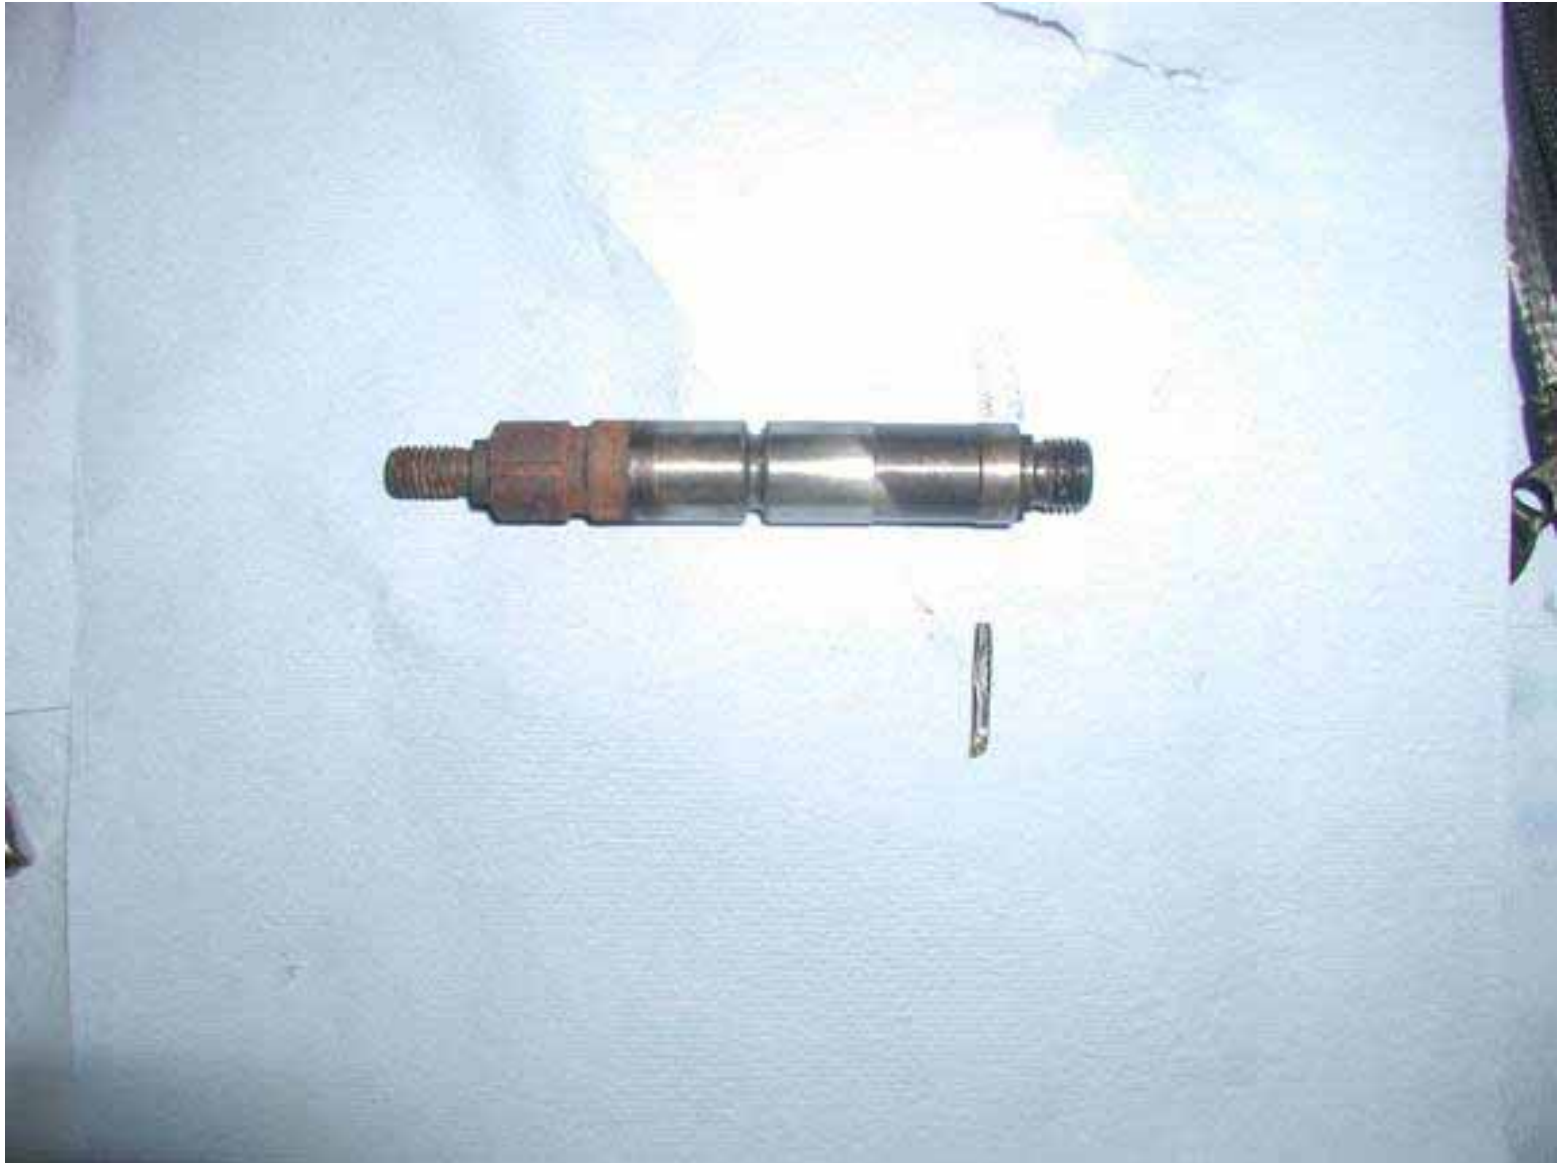
Manual lever shaft and retaining pin removed. Notice the worn area in the pin. Pin bent around the shaft inside the bore which turned a 10 minute job into a major headache.

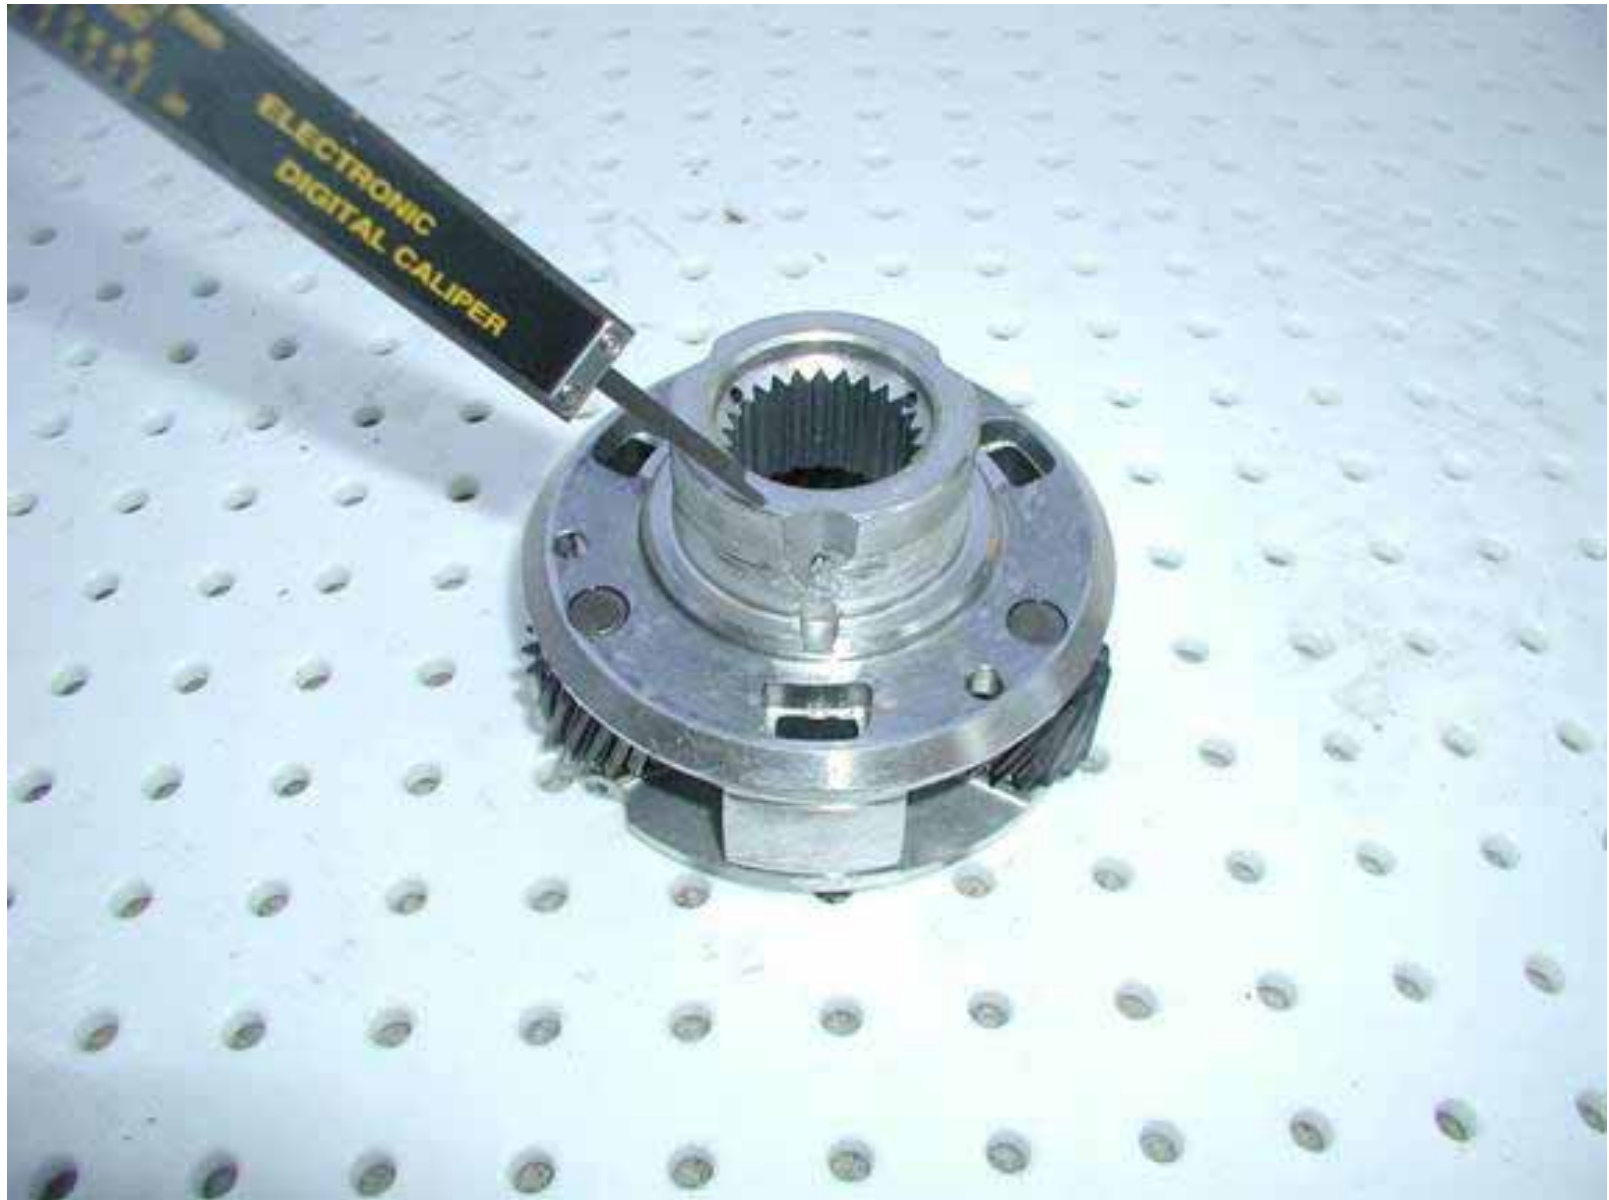
Common failure of aluminum gear set. Aluminum has galled and nearly blocked the lube hole. Major failure or the Grenade out the side of the case is the likely result. Stronger parts are the cure. Others put a repair sleeve over this and let it ride.

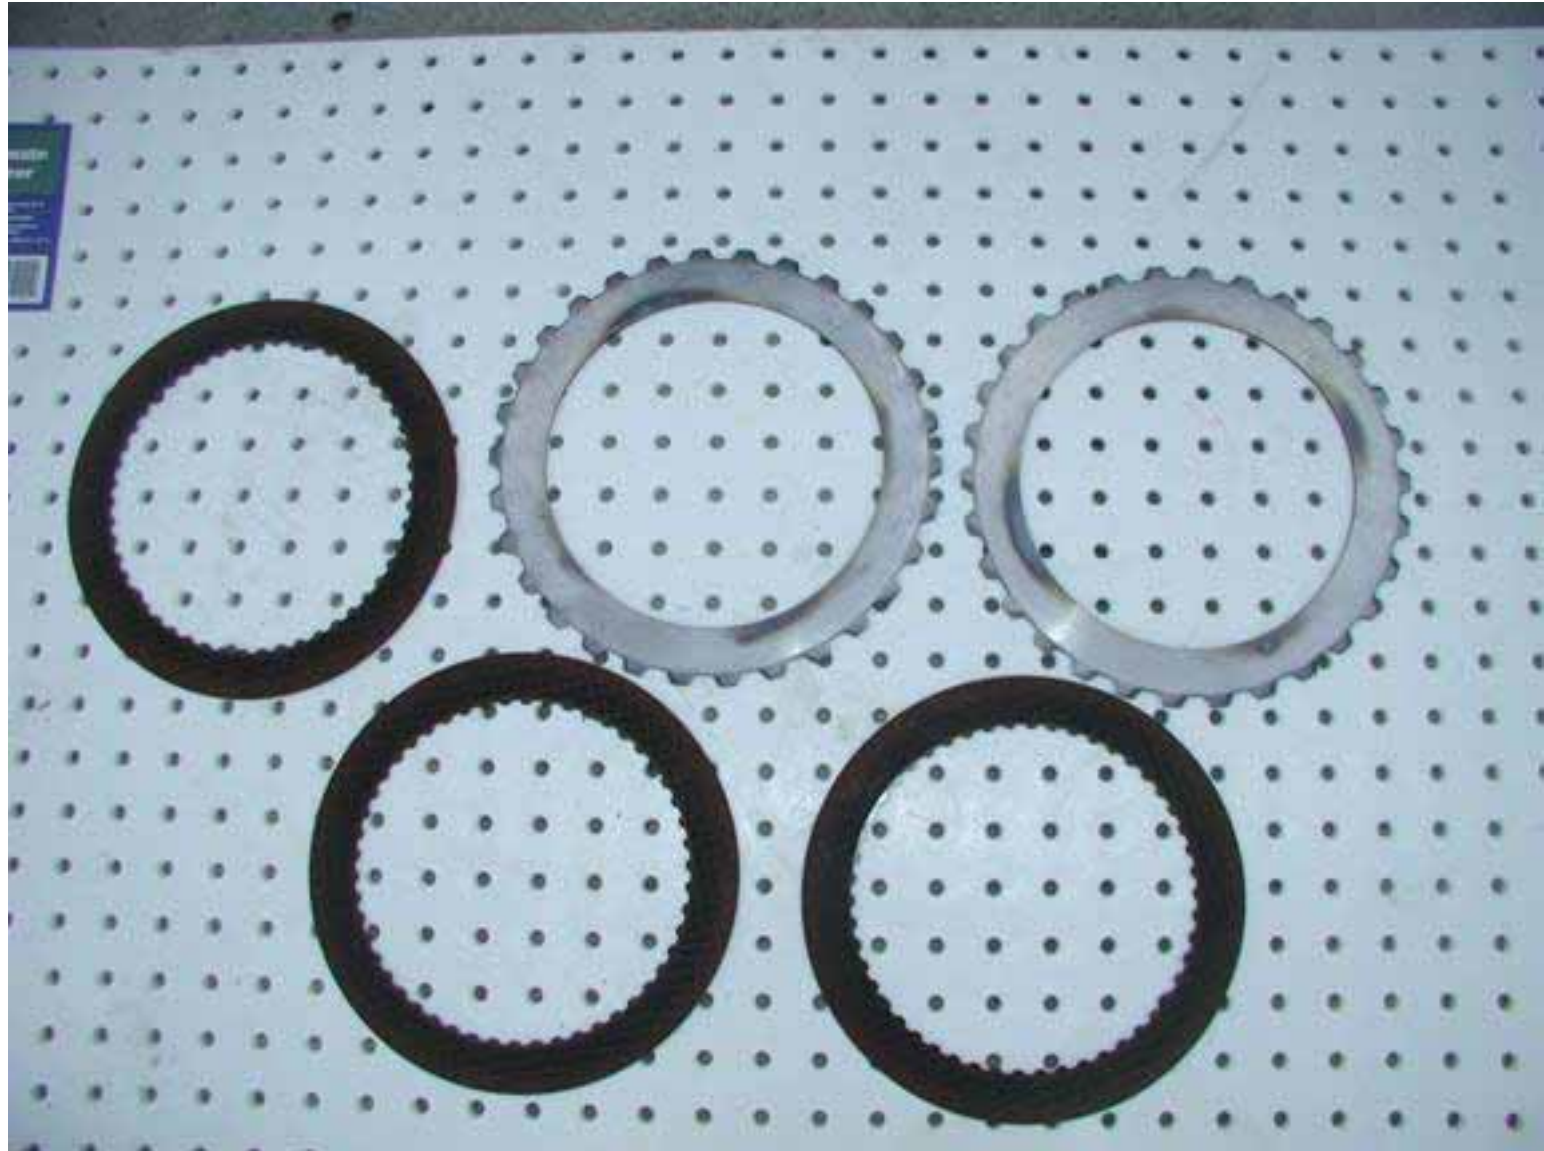
Burned intermediate frictions and steel plates from over heating clutch. Notice the blue heat marks on the steel plates. Fix is a stronger intermediate clutch and better friction materials

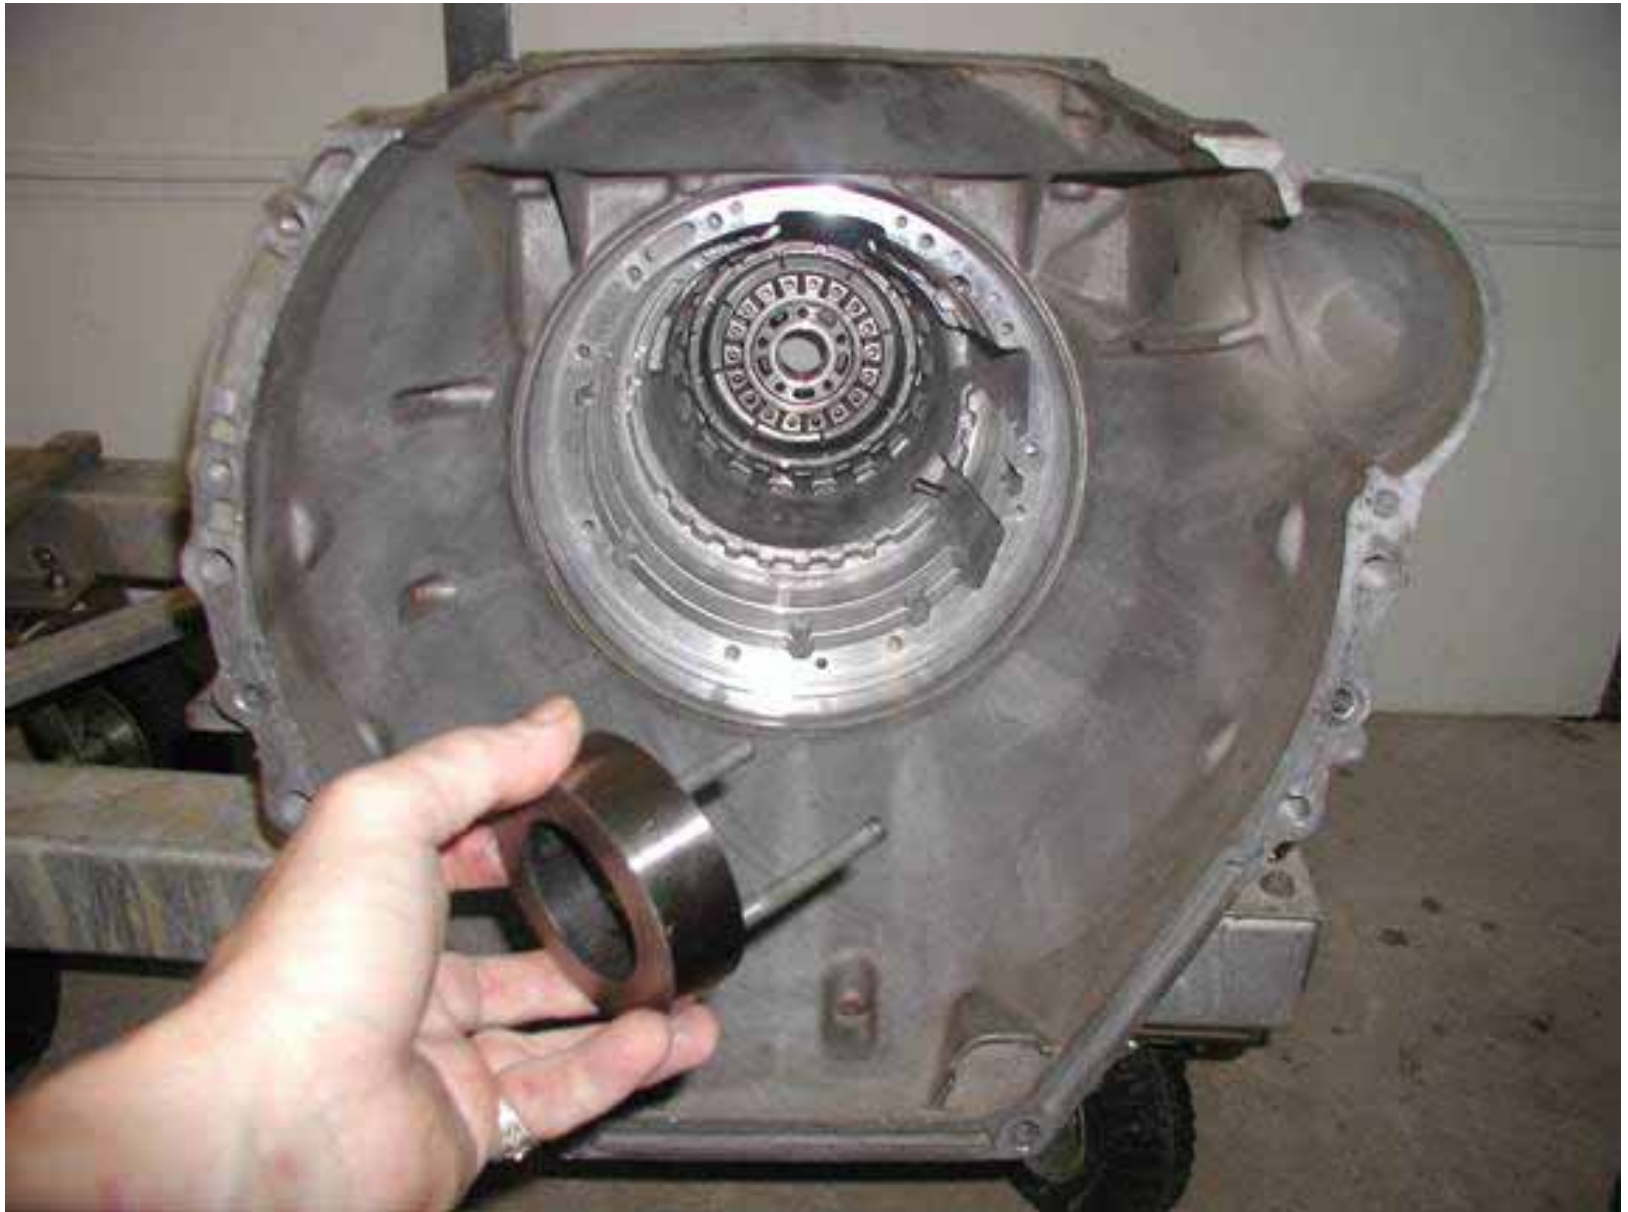
The low reverse one way clutch race is installed with aligning pins thru the mounting holes in the back of the case. It must be aligned properly with the lube hole in the 5 o'clock position. Otherwise lube failure can occur.
